JAMESTOWN GOLF COURSE FACILITY PROPOSAL

Jamestown Golf Course Clubhouse Facility History:

Jamestown Golf Course Clubhouse Facility

Existing Building Deficiencies

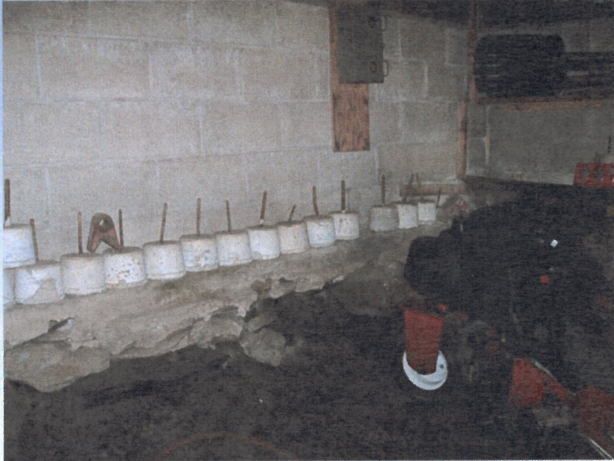
- The lower level framing (floor joists for upper level) are excessive spans for the joist dimensions, and do not, meet current building code requirements for the floor loading that is required for recreational and assembly activities.
- CMU wall footings on the lower level have been undermined and are not structurally sound.

Undermined footings

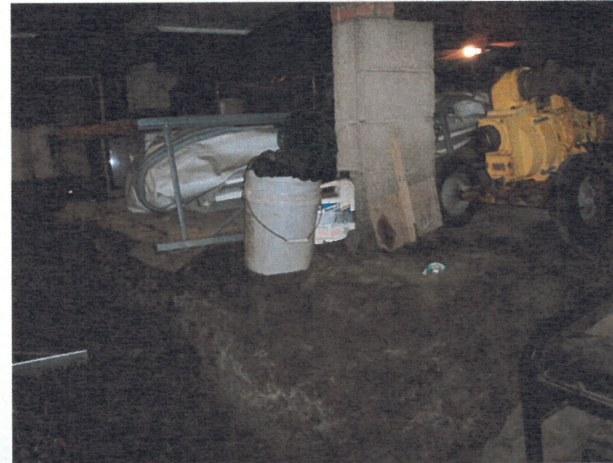
Unstable footings and support

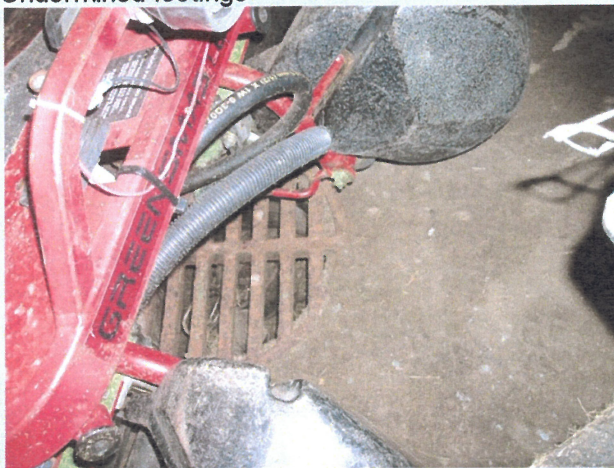
Blocked drain

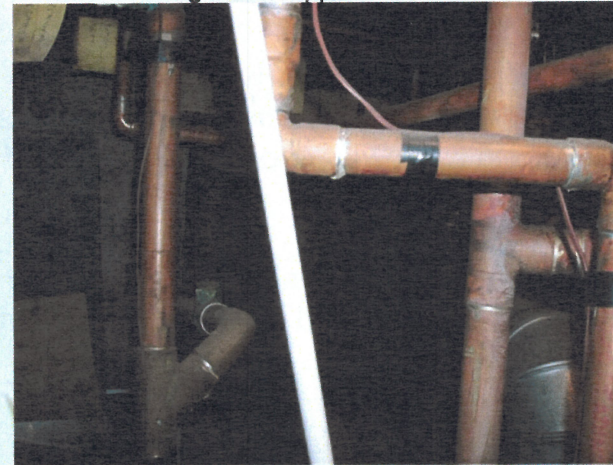
Piping and un-encased wiring

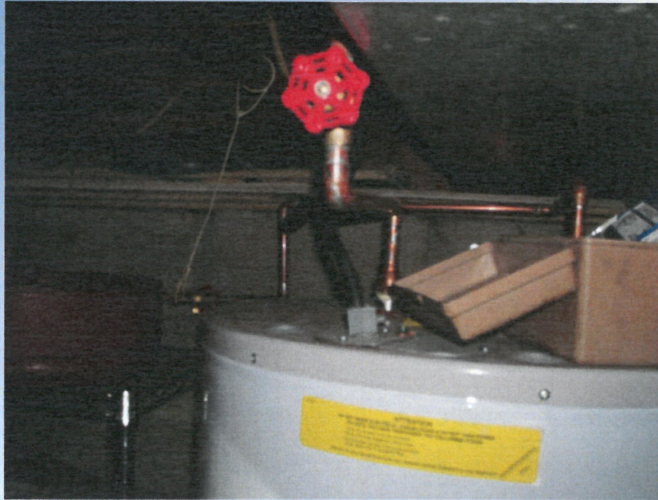
Supply wiring should be in metal conduit

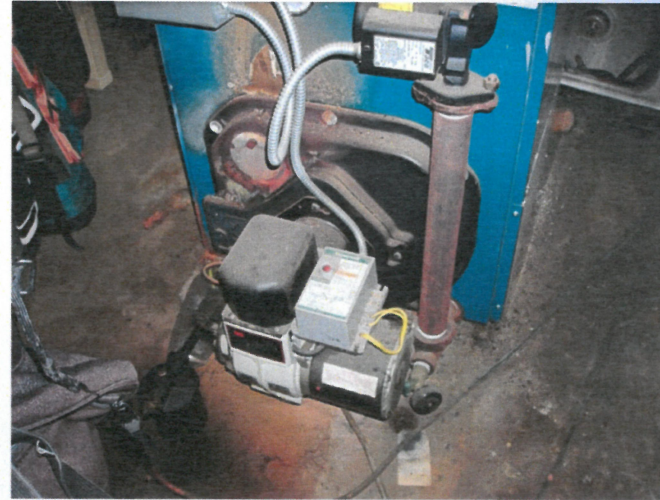
Corrosion at furnace

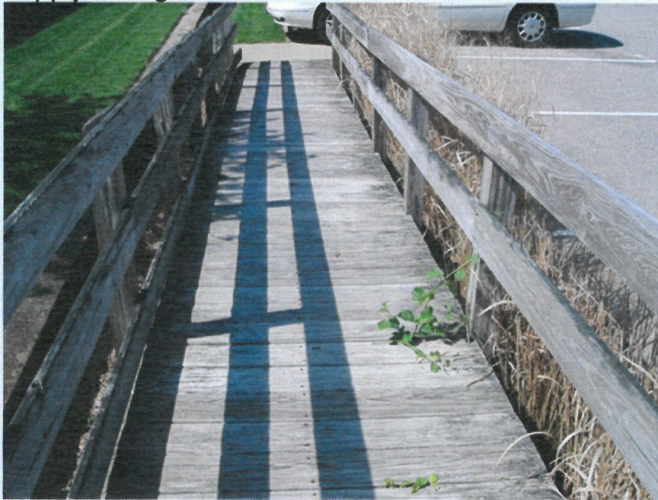
Maintenance required. Not in compliance with ADA

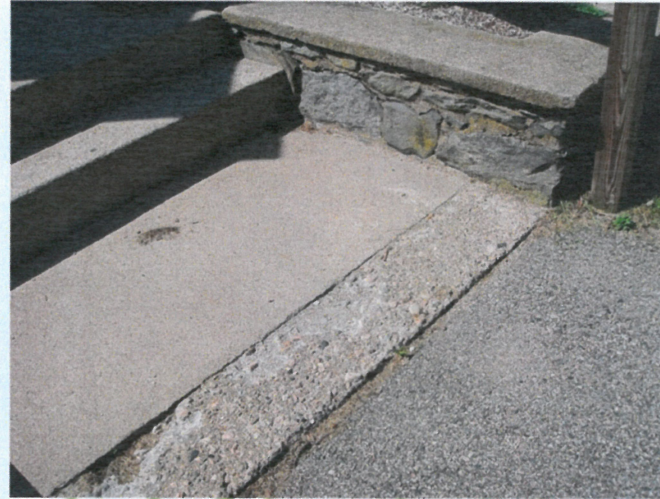
Paving corroding causing potential trip hazard

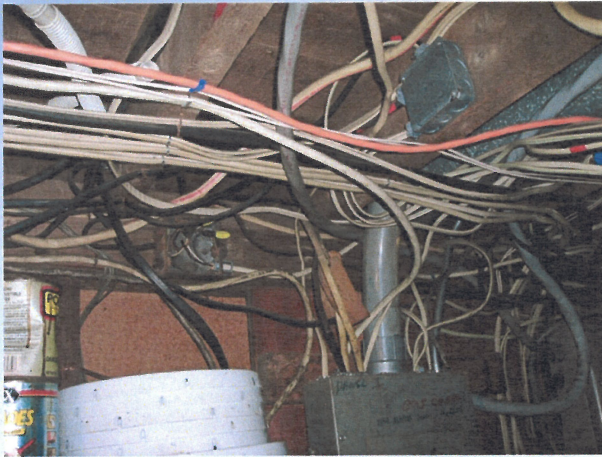
Electrical Code Issues

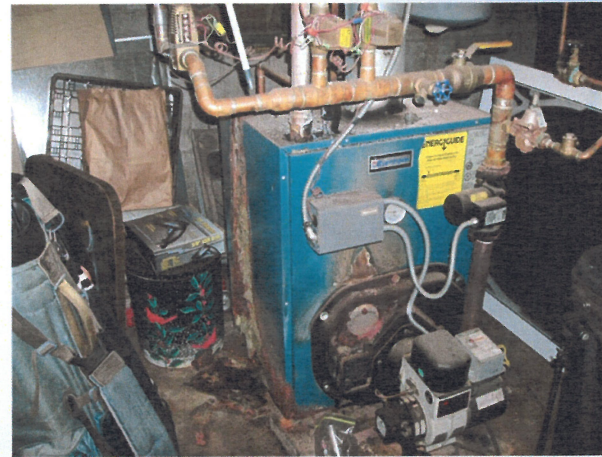
Current Heating Plant
