PARE PROJECT NO. 17103.00

**CLEAN WATER INFRASTRUCTURE
REPLACEMENT PLAN**

JAMESTOWN WATER DISTRICT

JULY 2019

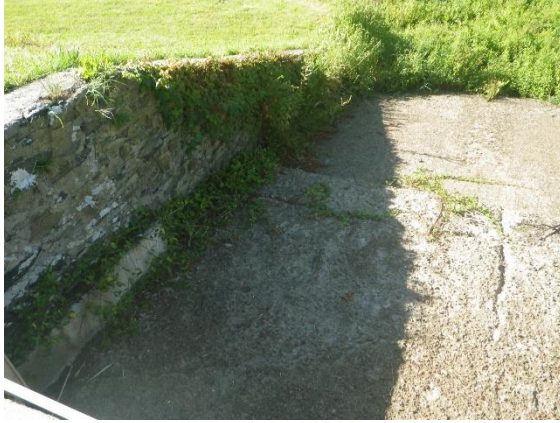
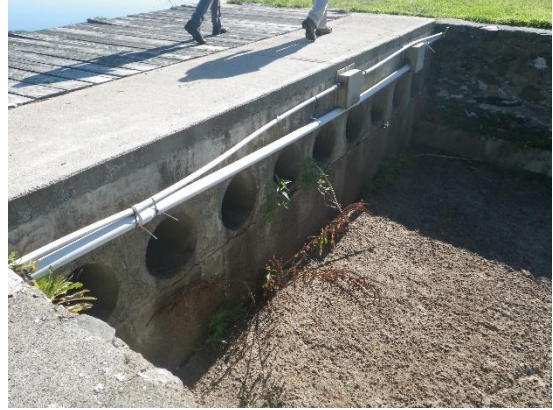
North Pond Spillway

Discharges from the pond flow through a 20-foot wide concrete spillway structure located at the western end of the embankment. Vegetation should be removed from the spillway retaining walls as part of a routine maintenance program.

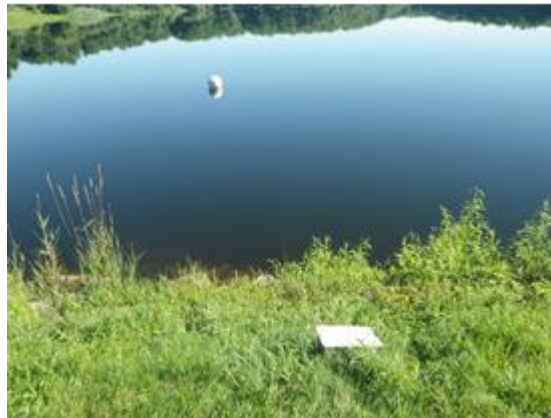
Intake at North Pond

The intake structure for the water supply system consists of a flexible intake pipe connected to a mooring set about 12” below the water surface to obtain the best water quality. The intake connects to a 10” pipe that penetrates the dam and carries the water by gravity to South Pond. The connection between the mooring and the dam penetration is reported to be in fair condition and will require a repair to ensure its long-term integrity.

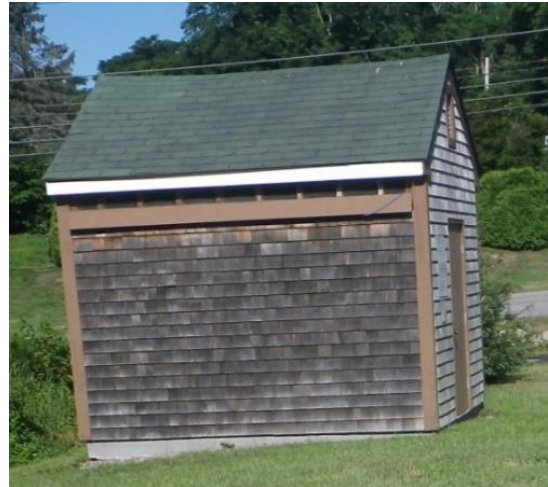
North Pond – Blower Building

A wood-frame building (constructed circa 1995) located west of the dam currently houses a blower motor and associated electrical controls that are part of an aeration system used to improve water quality in the pond. This system was installed circa 2012 which replaced the former compressed air system. Since the motor runs hot, two ventilation fans are used to keep the motor cool. The JWD should monitor this system and consider providing improved ventilation and cooling to preserve the life of the motors.

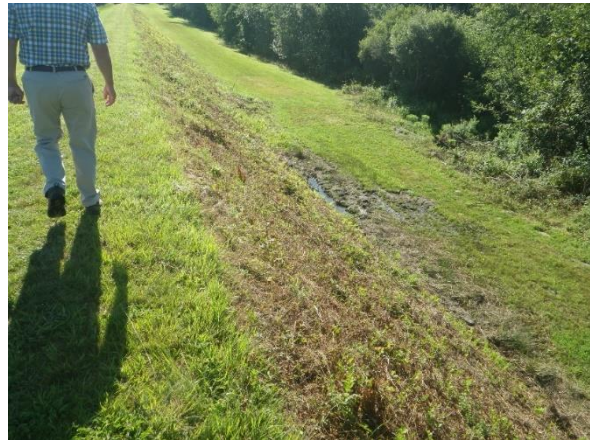
Active seepage was noted along the base of the dam, west of a blanket drain system installed in 2010. A bike trail project is currently in progress and includes installing a new bike trail along the toe of the existing dam. As part of this design, improvements to the dam including flattening the slope and extending the horizontal limits of the blanket drain system are also being completed. This project also includes rip-rap armoring of the waterward side of the dam. This work has been designed and is scheduled for completion in 2019.

*Seepage at Toe of North Pond Dam
(looking east)*

A blanket drain/toe drain was installed along a 70-foot section of the dam to control seepage in 2010. However, as previously noted, seepage was observed immediately to the east of the new blanket/toe drain. Prior to this the dam had been repaired in 1995 to improve its structural integrity. The spillway was modified in 1980, raising the water height in the reservoir by approximately 8 inches. It is currently in fair condition but may require rehabilitation within the next 5 years.

1. Repoint the spillway retaining wall
2. Locate and clear the toe drain outlet

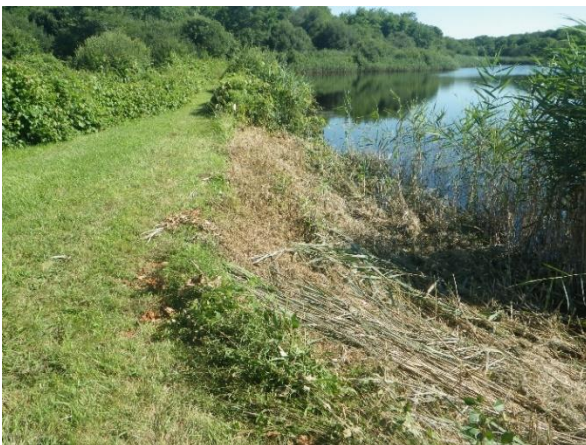
South Pond Dike Earthen Berm

Visual inspections performed by Pare as recently as 2013 identified concerns with the dam at South Pond that require remediation. Specifically, the dike was found to be deteriorated with low areas, breaches, root penetration and other deficiencies. It

was also identified that the spillway cannot accommodate a 2-year flood without the lower portion of the dike overtopping. It was recommended that a new spillway with larger capacity be constructed should the dike be reconstructed, or a new smaller-sized spillway be constructed with the low section of the dike converted to a more permanent, armored overflow section spillway.

In 2018, Pare prepared design documents for the completion of a rehabilitation program at the dam and dike at South Pond to address the issues raised in previous visual inspections including the deteriorated condition of the dike, seepage, inadequate spillway discharge capacity, and lack of upstream slope protection. The designs consists of the following components:

9. Install riprap scour protection along the downstream toe of the dike;
10. Complete a permeation grouting program at the primary spillway to reduce observed seepage.

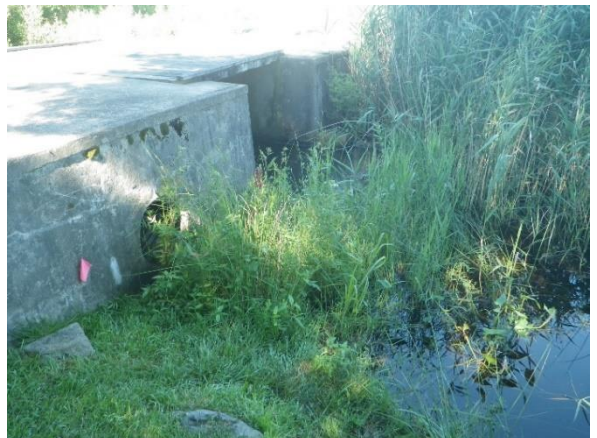
South Pond Spillway

existing spillway consists of an approximately 9-foot wide cast-in-place concrete overflow spillway section with roughly 14-foot by 13-foot rectangular concrete abutments at either side. Immediately upstream of the spillway, a small stilling basin is located with a rim set to allow flow during normal pool elevations. During periods of low flow, discharge is via a bubbler set in the middle of the stilling basin below the normal pool level. The bubbler is fed by a deep-water intake reportedly located approximately 100-feet upstream of the embankment. A concrete apron covers a portion of the slope downstream of the spillway before transitioning to a stone lined discharge channel. Past visual inspections by Pare report this concrete apron to be deteriorating. During periods of elevated pool levels, 18-inch diameter conduits passing through each concrete abutment provide additional capacity.

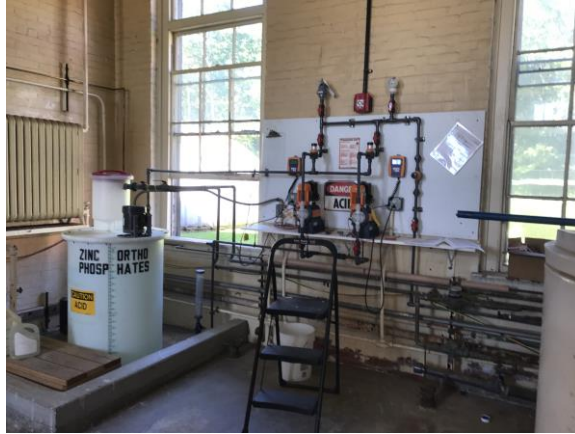
The former treatment facility building is over 100 years old and is currently used for storage, workshop and corrosion control. The raw water wetwell is original to the previous treatment plant, as is the finished water pump station and the sludge dewatering tank.

*Old Treatment Plant Building
Corrosion Control System*

Time Interval/Year	Description	Opinion of Probable Construction Cost
5-year/2020	Replace Roof and Windows on Original Treatment Building	\$40,000
	Replace membranes (15-year life span); tank improvements	\$310,000*
	Replace Static Mixers	\$5,000
10-year/2029	Inspect and Service Generator, Pumps, & Other Components	\$15,000
10-year/2029	Replace Permeate Pumps	\$25,000
10-year/2029	Replace Blowers	\$50,000
15-year/2034	Perform Inspection of Treatment Facility	\$5,000
20-year/2039	Inspect and Service Generator, Pumps, & Other Components	\$15,000

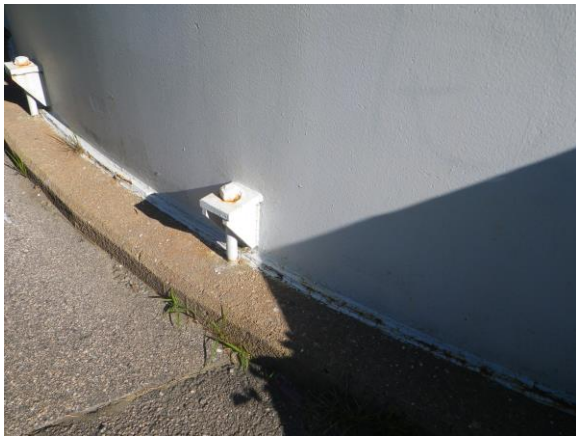
Standpipe #1 Anchor Bolts

The tank was most recently inspected and cleaned in June 2013. The inspection report recommended recoating the entire interior and exterior within 5 years and to repair or replace the anchor bolt nuts. Chain link fence was installed around the site in 2007 when the new standpipe was constructed, which appears to be in good condition.

Time Interval/Year	Description	Opinion of Probable Construction Cost
5-year/2019	Perform inspection	\$5,000
5-year/2020	Welding repairs/refurbish interior & exterior protective coatings	\$400,000*
5-year/2024	Perform tank inspection	\$5,000
10-year/2029	Perform tank inspection	\$6,000
15-year/2034	Perform tank inspection	\$7,000
20-year/2039	Perform tank inspection	\$8,000

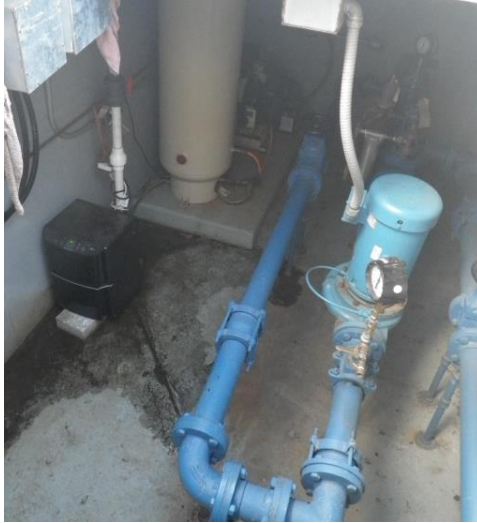
Tank Transfer Pump/Vault

In 2007 a new pump was installed to allow the transfer of water between standpipes. It has not been used yet. It should be exercised regularly.

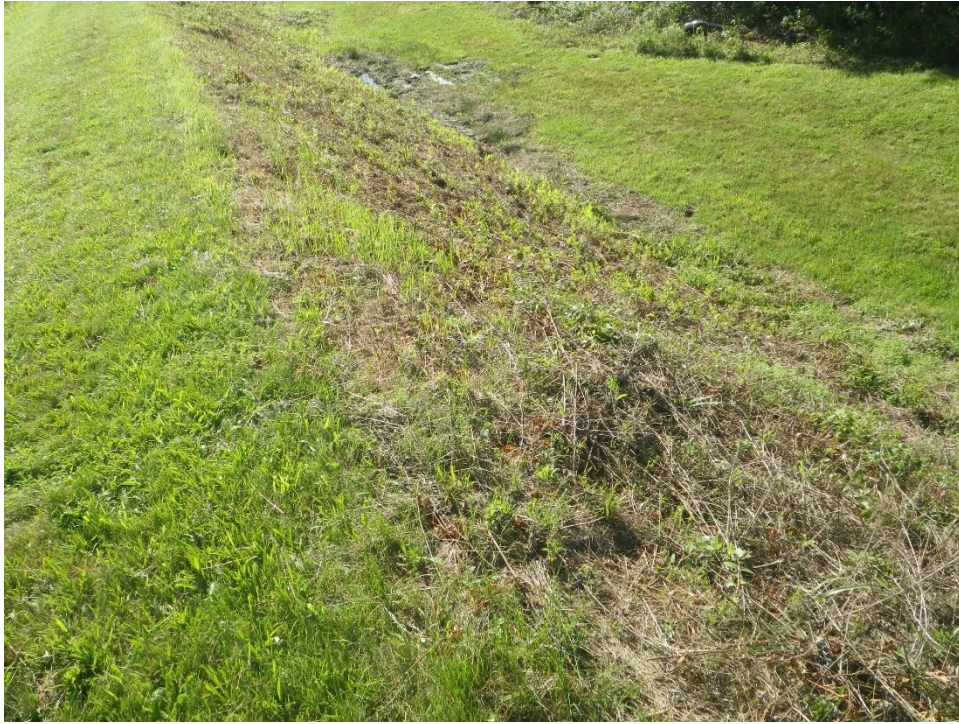
AREA OF NOTED SEEPAGE
