PARE PROJECT NO. 17103.00

**CLEAN WATER INFRASTRUCTURE
REPLACEMENT PLAN**

JAMESTOWN WATER DISTRICT

JULY 2019

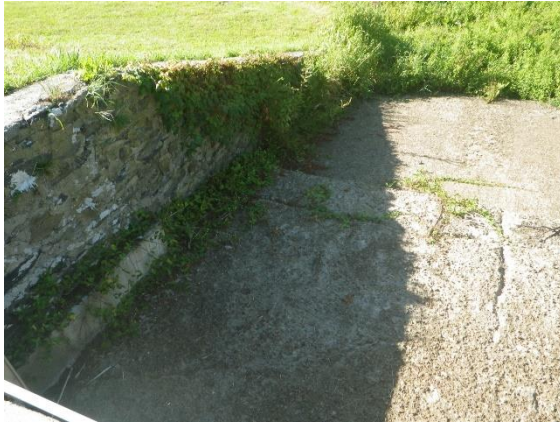
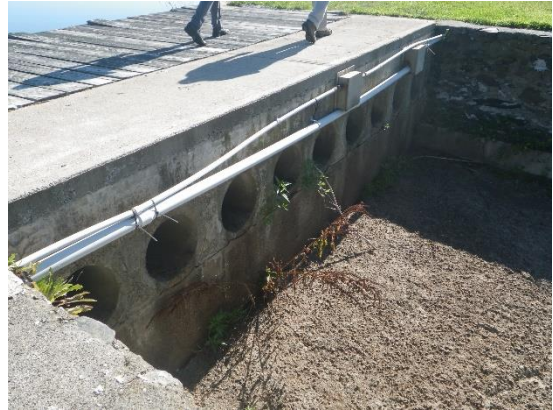
North Pond Spillway

Discharges from the pond flow through a 20-foot wide concrete spillway structure located at the western end of the embankment. Vegetation should be removed from the spillway retaining walls as part of a routine maintenance program.

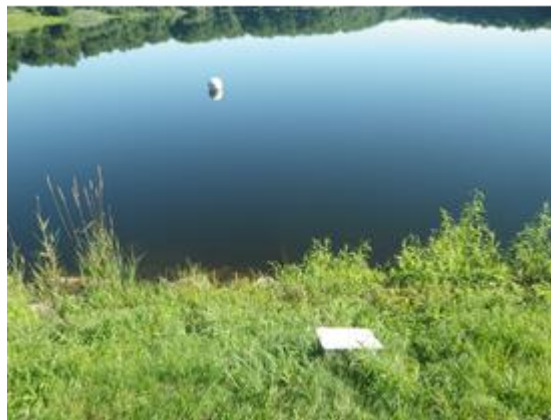
Intake at North Pond

The intake structure for the water supply system consists of a flexible intake pipe connected to a mooring set about 12” below the water surface to obtain the best water quality. The intake connects to a 10” pipe that penetrates the dam and carries the water by gravity to South Pond. The connection between the mooring and the dam penetration is reported to be in fair condition and will require a repair to ensure its long-term integrity.

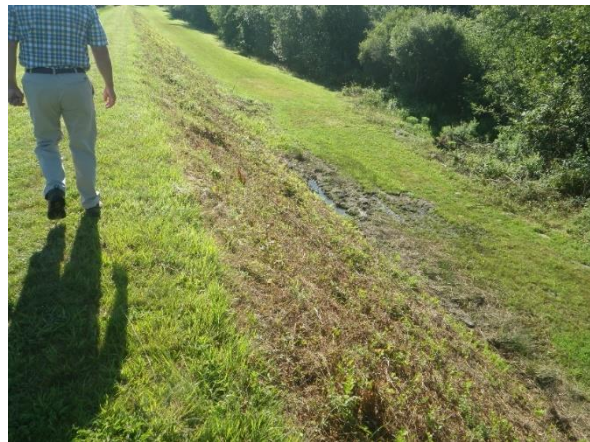
Active seepage was noted along the base of the dam, west of a blanket drain system installed in 2010. A bike trail project is currently in progress and includes installing a new bike trail along the toe of the existing dam. As part of this design, improvements to the dam including flattening the slope and extending the horizontal limits of the blanket drain system are also being completed. This project also includes rip-rap armoring of the waterward side of the dam. This work has been designed and is scheduled for completion in 2019.

*Seepage at Toe of North Pond Dam
(looking east)*

A blanket drain/toe drain was installed along a 70-foot section of the dam to control seepage in 2010. However, as previously noted, seepage was observed immediately to the east of the new blanket/toe drain. Prior to this the dam had been repaired in 1995 to improve its structural integrity. The spillway was modified in 1980, raising the water height in the reservoir by approximately 8 inches. It is currently in fair condition but may require rehabilitation within the next 5 years.

1. Repoint the spillway retaining wall
2. Locate and clear the toe drain outlet

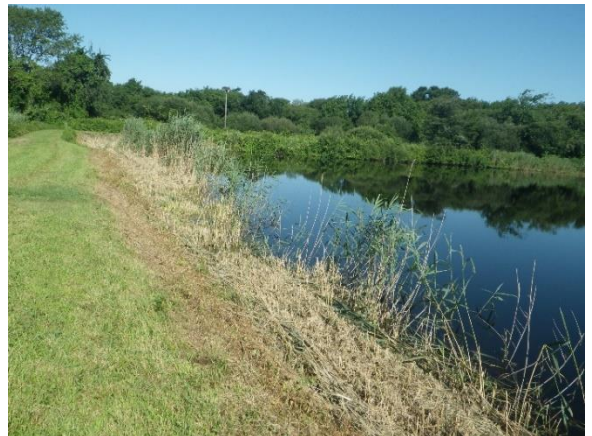
South Pond Dam Embankment

<u>Spillway</u> : Undersized, requires improved scour protection per 2007 evaluation	5 years
<u>Earthen Embankment Dam (southern section)</u> : Unable to inspect due to overgrowth	5 years
<u>Earthen Dike (western section of dam)</u> : Significantly degraded. In need of repair	5 years
<u>Intake structure and area</u> : Good, rebuilt in 2012	20 years

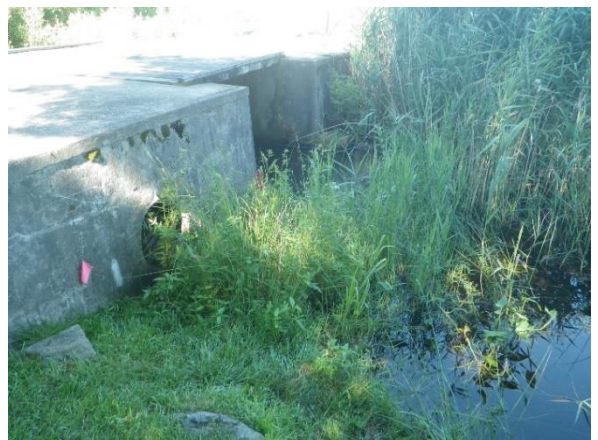
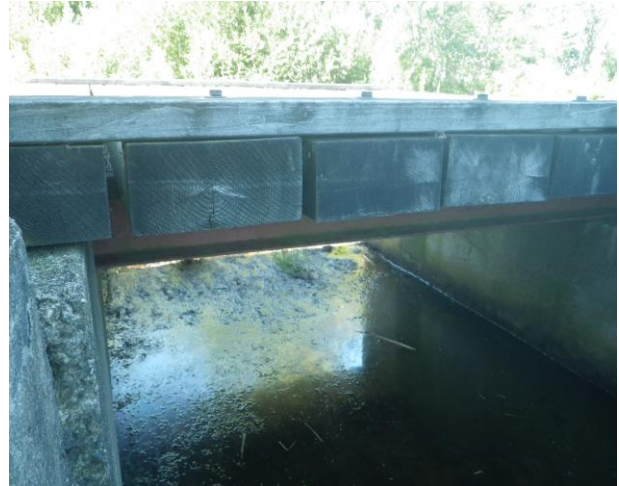
South Pond Spillway

was also identified that the spillway cannot accommodate a 2-year flood without the lower portion of the dike overtopping. It was recommended that a new spillway with larger capacity be constructed should the dike be reconstructed, or a new smaller-sized spillway be constructed with the low section of the dike converted to a more permanent, armored overflow section spillway.

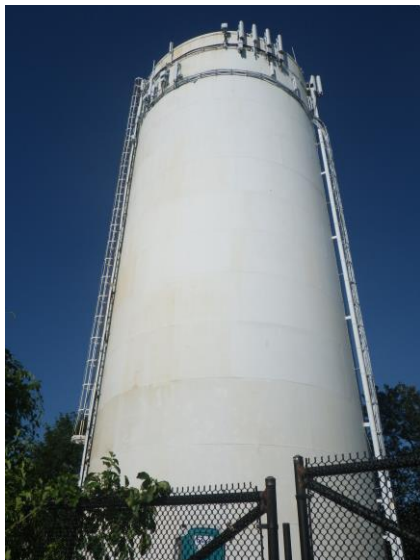
Howland Avenue Standpipe #1

Recent Rehabilitation/Repairs: The tank interior was sandblasted to bare metal, spot primed, and repainted in 1998. The exterior of the tank was also water blasted and encapsulated with two coatings at this time as well. The JWD made repairs to the overflow flap valve, rendering it operable, and also replaced the tank vault vent screen with No. 24 mesh circa 2000.

<u>Structure</u> : Good, per most recent inspection report	25-30 years
<u>Protective Coatings</u> : fair, recommended to be repainted	1 year
<u>Concrete Foundation</u> : Very Good, per most recent inspection report	25-30 years
<u>Altitude Valve/Piping/Vault</u> : Very Good, per most recent inspection report	25-30 years

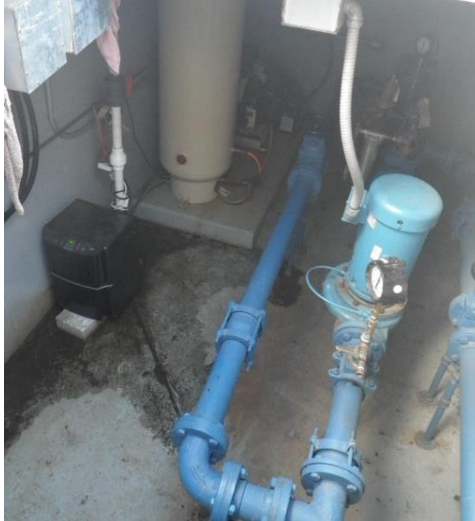
Tank Transfer Pump/Vault

In 2007 a new pump was installed to allow the transfer of water between standpipes. It has not been used yet. It should be exercised regularly.
