Jamestown Harbor Commission Meeting
Wednesday, May 8, 2024 at 5:00 p.m.
Jamestown Town Hall
93 Narragansett Avenue, Jamestown, RI 02835

Report of Findings Fort Getty Pier Inspection Jamestown, Rhode Island

Town of Jamestown
Jamestown, Rhode Island

April 2024

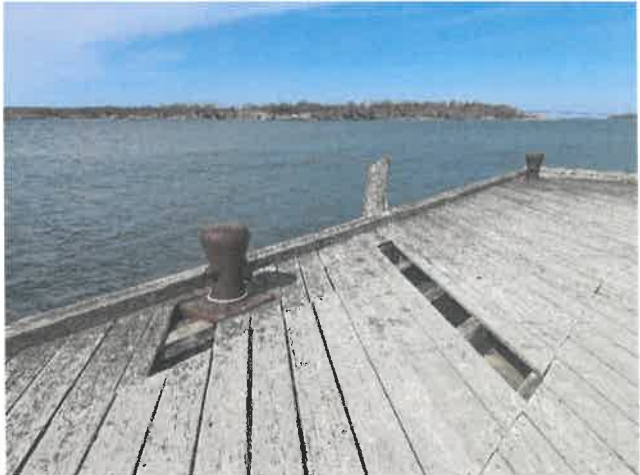
Photo No. 3	Date: 3/1/24

Direction Photo Taken: Northwest		
Photo Taken By: HAC		
Description: Typical mooring hardware and deck construction

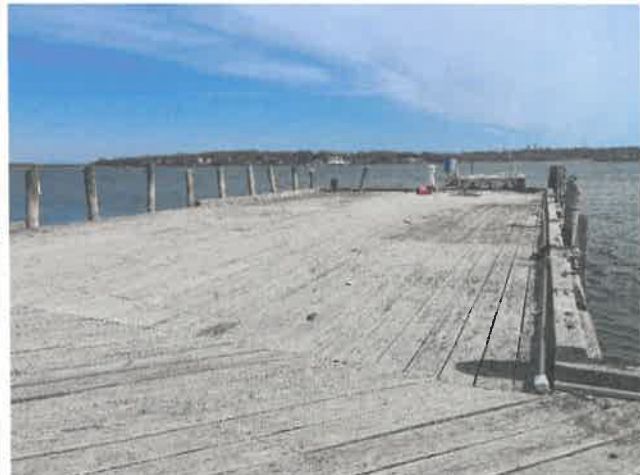
Photo No. 4	Date: 3/1/24

Direction Photo Taken: Northeast		
Photo Taken By: HAC		
Description: Overview of seaward portion from end of approach way

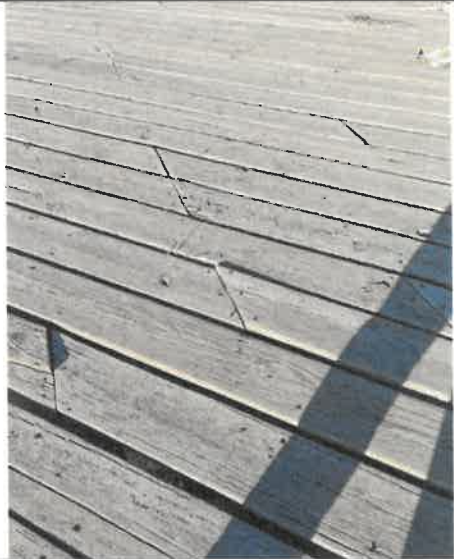
Photo No. 11	Date: 3/1/24

Direction Photo Taken: North		
Photo Taken By: HAC		
Description: Typical decking condition

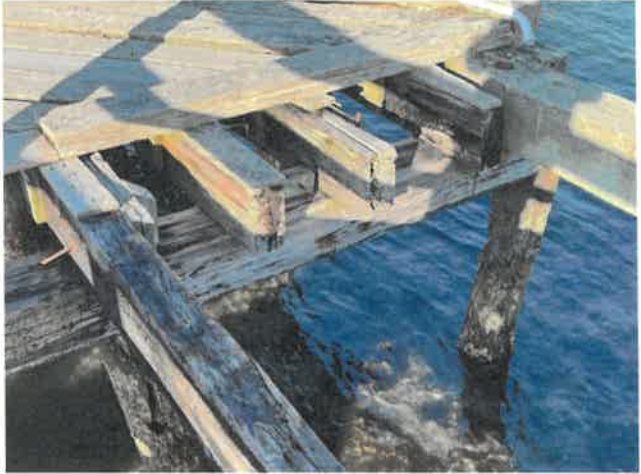
Photo No. 12	Date: 3/1/24

Direction Photo Taken: Northeast		
Photo Taken By: HAC		
Description: Typical condition at approach way

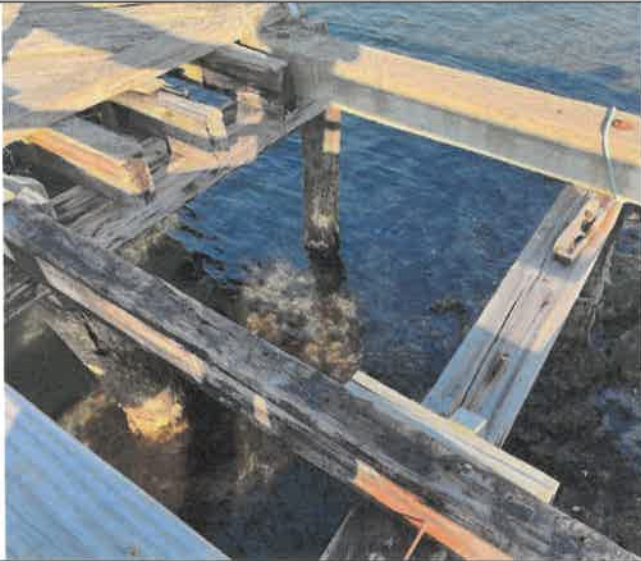
Photo No. 13	Date: 3/1/24

Direction Photo Taken: East			Direction Photo Taken:		
Photo Taken By: HAC			Photo Taken By: Fathom		
Description: Typical pile cap condition at approach way			Description: Typical abandoned hardware holes & corrosion (Pile 15M)

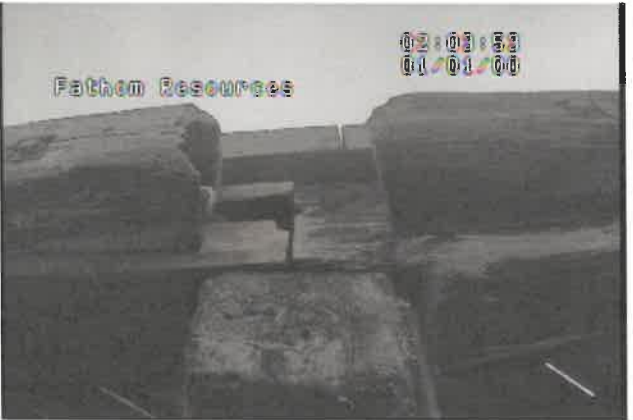
Photo No.: 25	Date: 3/1/24

Direction Photo Taken:			Direction Photo Taken:		
Photo Taken By: Fathom			Photo Taken By: Fathom		
Description: Wale and stringer condition (Pile 1M)			Description: Typical condition of pile near cap (Pile 5K)

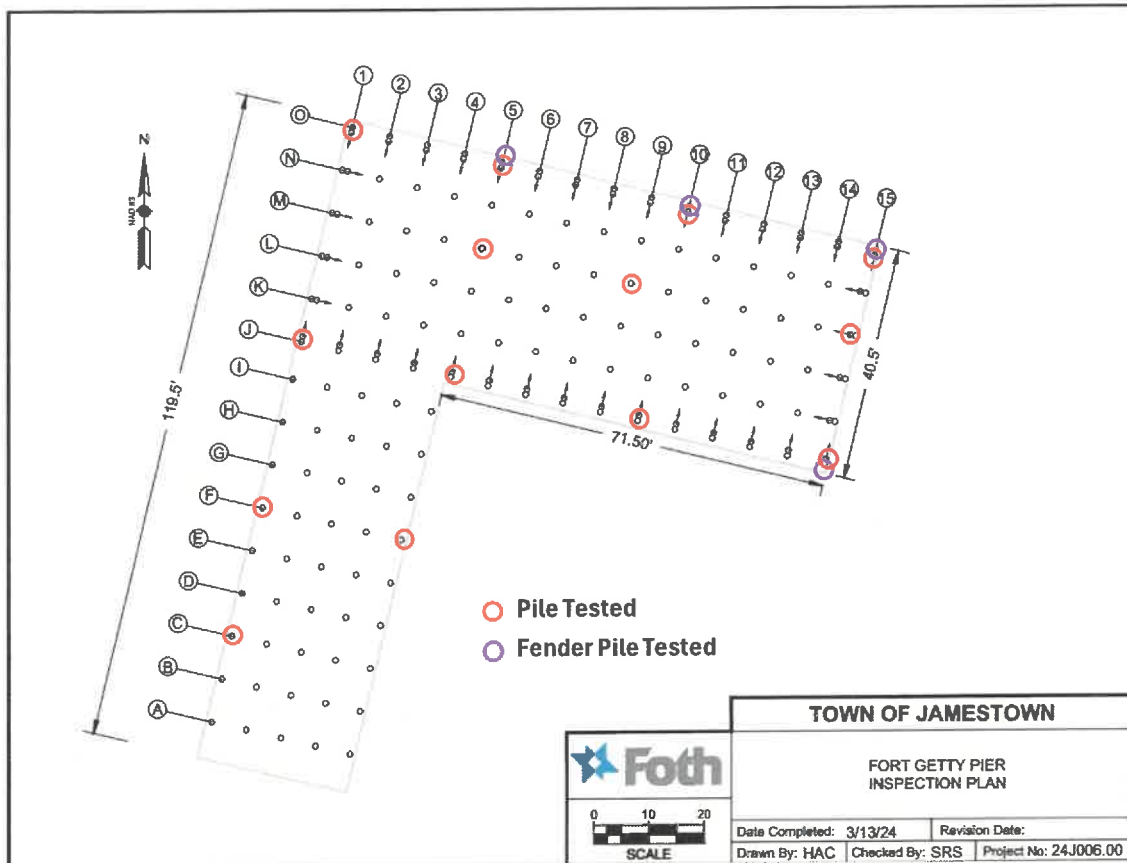
Figure 2: Inspection Plan for Fort Getty Pier with locations of piles test.

NDT Division conducted sonic reflection measurements on a total of 18 individual timber piles consisting of 14 piles supporting the structure and 4 fender piles. All piles tested were selected by Foth. Individual pile information including the distance from the top of pile to the mud line were manually measured using a tape at each test location. Figure 2 below is the inspection plan provided by Foth with the approximate location of each pile tested shown as a red circle and each fender pile identified with a purple circle.
