# WWTF & Pump Station Evaluation

FINAL Report

September 2024

TOWN OF JAMESTOWN, RHODE ISLAND

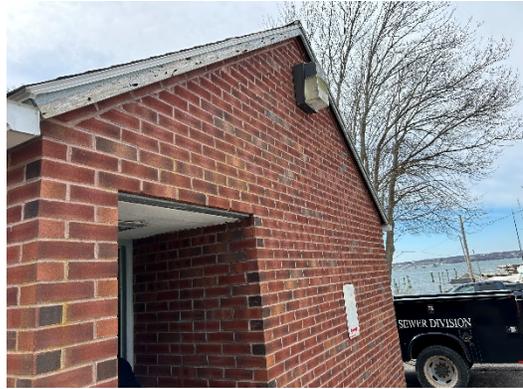
Figure 1 – Pump Station no. 3 Structure

Pump Station #3 consists of a building and a vertical wetwell below. The wetwell is accessed by a hatch and ladder on the floor of the pump station building. This structure was observed to be in good condition.

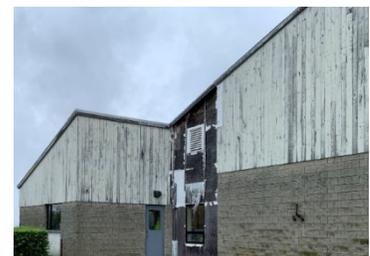
Figure 3 – Control Bldg. Façade

There are six personnel doors located around the building which are all in fair condition. Door hardware throughout the building is dated and the locksets are “knob” style. There are two coiling doors. Both coiling doors have issues with opening and closing.

The building's windows were replaced in the 2007 renovation without screens. Since then, there is visible water damage around the cased windows on the North side of the building. The windows have, for the most part, failed throughout the building.

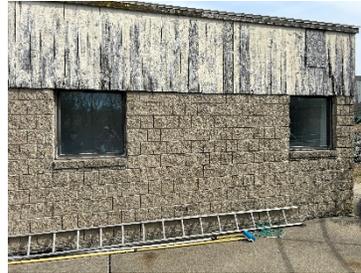
Figure 5 – RAS Bldg.

The RAS Building is in relatively good condition. The roof needs replacement and that would align with the work on the main control building. The skylight on the tanks needs replacement due to age. The tongue & groove siding needs replacement like the main building. However, the interior is in relatively good shape.

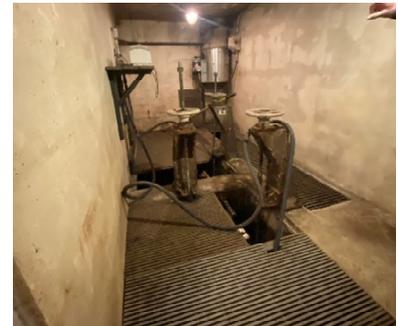
Figure 6 – Pump Station no. 2 Wet Well

On the wet well side of Pump Stations #1 and #2 there are sluice gates with operators in the influent channel. These gates are heavily worn and corroded. The system operators report that the gates have become difficult to operate due to their condition. All of these sluice gates need to be replaced.

Pump Stations #1 and #2 have existing wet wells that include an influent channel with gates to split the flow to either half of the wet well (see Figure 6). These channels need to be repaired and the gates (three at each station) need to be replaced to regain functionality. These are included in priority group 1 for the Pump Stations.

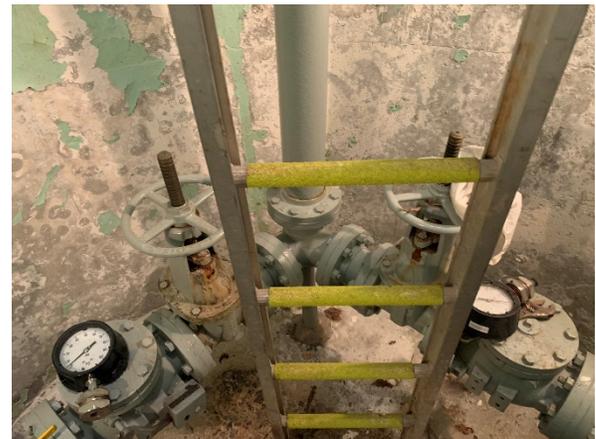
Figure 7 – Pump Station no. 3 Dry Well

Two process adjustments are needed for the pump stations. The first is the replacement of the raw sewage pumps in Pump Station #3. Pump Station #3 has large variations in its influent flow, receiving minimal flow during dry periods and high flow during rain events. The raw sewage pumps in the station cannot handle the influent flow during large rain events. These pumps need to be replaced with larger pumps that can manage the high inflow during rain events. Maximum inflow into the station during rain events is approximately 500 gallons per minute (gpm). Therefore, the replacement pumps must be rated to pump a minimum of 250 gpm each. Additionally, because the pump station receives minimal flow during dry periods, the replacement pumps should be VFD operated to allow for variable pumping rates. This will minimize unnecessary wear on the pumps.

The other process alteration recommended for pump stations is the replacement of the RAW sewage pumps in Station #3. These pumps need to be replaced with new pumps that can provide adjustable pumping rates to match the changing inflow into the station. Additionally, the pumps need to be upgraded to models that provide sufficient pumping rates to meet the station's needs during peak flow periods, as this lift station receives a large fluctuation in flows. To achieve these two functions, Weston & Sampson recommends replacement pumps be VFD controlled to change their pumping rate based on the water levels in the wet well. There is only space for two pumps in the existing dry well, but in order to provide the most reliable system, it is recommended to install a suction lift pump outside the lift station wetwell

in addition to the two dry-pit submersible pumps that would replace the existing. The suction lift pump could provide a higher capacity to assist with high flow situations. This upgrade is included in priority group 1 for the pump stations. The cost of the new pumps and appurtenances is included for reference as the replacement cost shown in Appendix B for the current Pump Station #3 pumps.
