# Clarke St. Substation Equipment Replacement Project

Town Meeting  
December 2, 2014

# Project Description

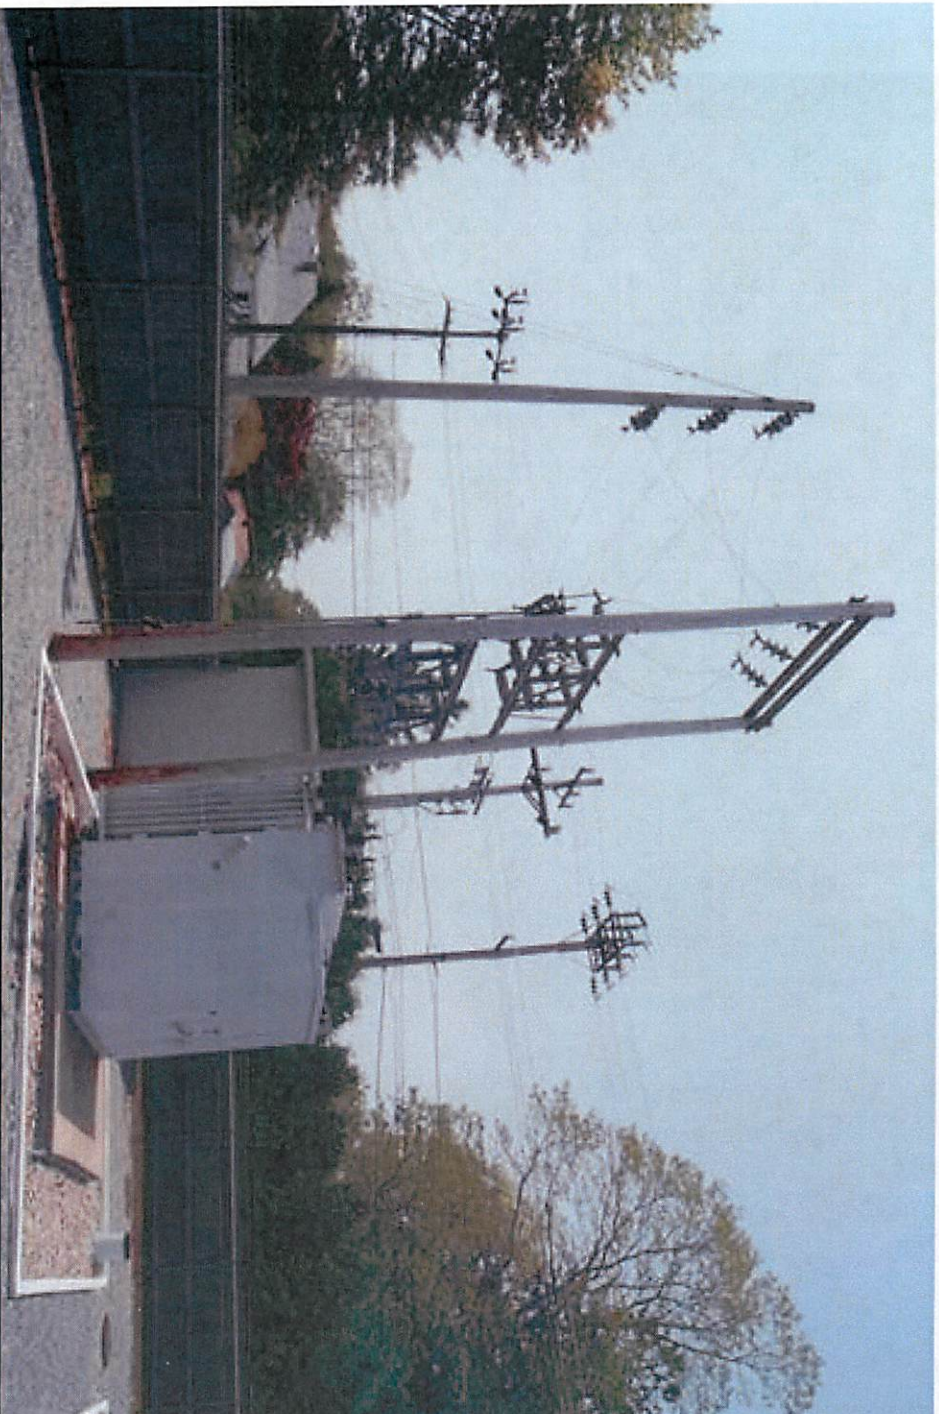
## Existing Transformer to Be Replaced

View facing Clarke St

- 65J12 is no longer reliable and needs to be replaced.
  - If the 65J12 feeder equipment is left in service, there is an elevated risk of a prolonged outage in southern Jamestown.

- All existing equipment associated with the 65J12 feeder will be retired and removed from the site.

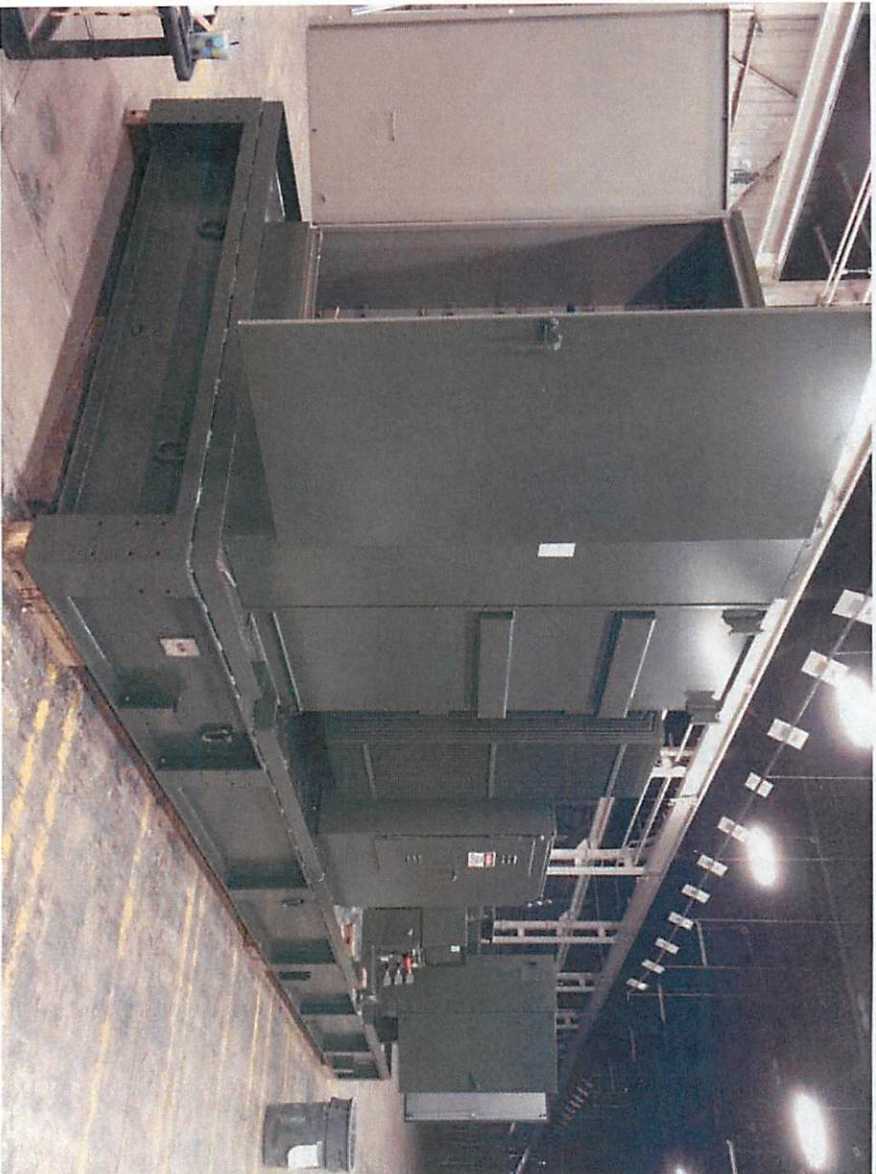
## Proposed MITS Skid

- MITS Dimensions: 10' Wide x 39' Long x 10' 5" High
- Walkway not pictured

- Upgrades Required:
  - Replace the 65J12 feeder equipment.
  - The new equipment will be of greater capacity to handle present and projected loading.
  - To minimize the visual impact, equipment encased in a metal-clad housing will be utilized.
