PARE PROJECT NO. 17103.00

**CLEAN WATER INFRASTRUCTURE
REPLACEMENT PLAN**

JAMESTOWN WATER DISTRICT

JULY 2019

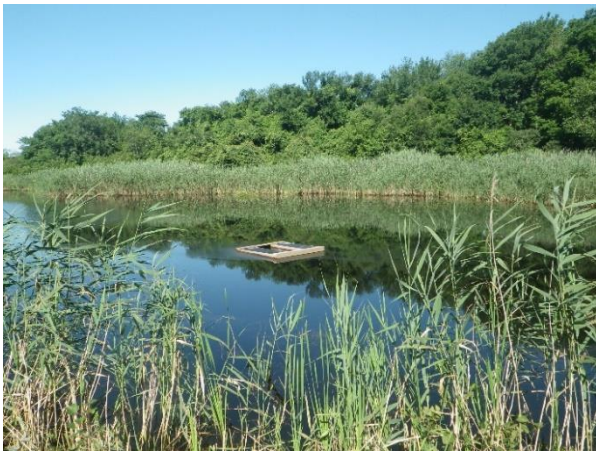
South Pond Intake Structure

A floating intake structure is located on the northern tip of the reservoir which contains two horizontal turbine pumps rated at 150 gpm and 300 gpm. The pumps are controlled manually and discharge to a 6” HDPE force main that runs directly to, and discharges in, the northern portion of North Pond.

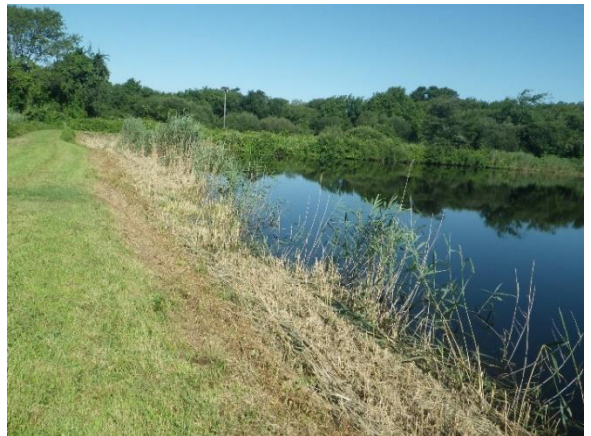
South Pond Dam Embankment

Visual inspections performed by Pare as recently as 2013 identified concerns with the dam at South Pond that require remediation. Specifically, the dike was found to be deteriorated with low areas, breaches, root penetration and other deficiencies. It

was also identified that the spillway cannot accommodate a 2-year flood without the lower portion of the dike overtopping. It was recommended that a new spillway with larger capacity be constructed should the dike be reconstructed, or a new smaller-sized spillway be constructed with the low section of the dike converted to a more permanent, armored overflow section spillway.

In 2018, Pare prepared design documents for the completion of a rehabilitation program at the dam and dike at South Pond to address the issues raised in previous visual inspections including the deteriorated condition of the dike, seepage, inadequate spillway discharge capacity, and lack of upstream slope protection. The designs consists of the following components:

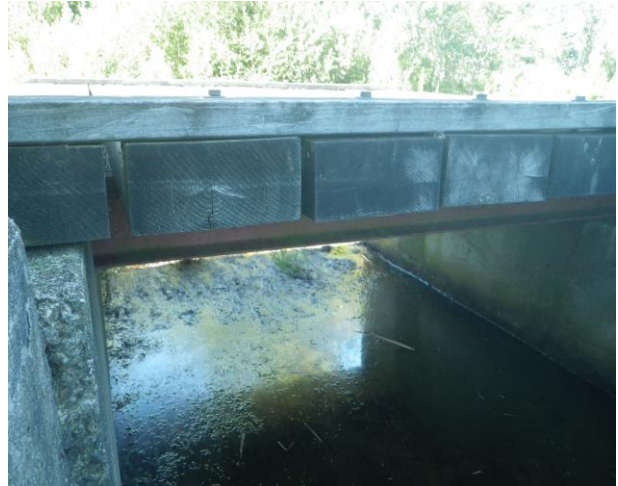
South Pond Spillway

existing spillway consists of an approximately 9-foot wide cast-in-place concrete overflow spillway section with roughly 14-foot by 13-foot rectangular concrete abutments at either side. Immediately upstream of the spillway, a small stilling basin is located with a rim set to allow flow during normal pool elevations. During periods of low flow, discharge is via a bubbler set in the middle of the stilling basin below the normal pool level. The bubbler is fed by a deep-water intake reportedly located approximately 100-feet upstream of the embankment. A concrete apron covers a portion of the slope downstream of the spillway before transitioning to a stone lined discharge channel. Past visual inspections by Pare report this concrete apron to be deteriorating. During periods of elevated pool levels, 18-inch diameter conduits passing through each concrete abutment provide additional capacity.

9. Install riprap scour protection along the downstream toe of the dike;
10. Complete a permeation grouting program at the primary spillway to reduce observed seepage.

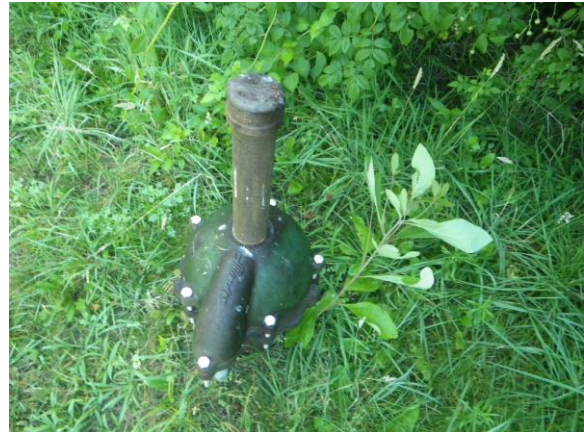
JR-1 Well head

A new pump and controls were installed in 2012. The JWD has not experienced any significant problems with production well JR-1 and it is considered to be in very good condition.

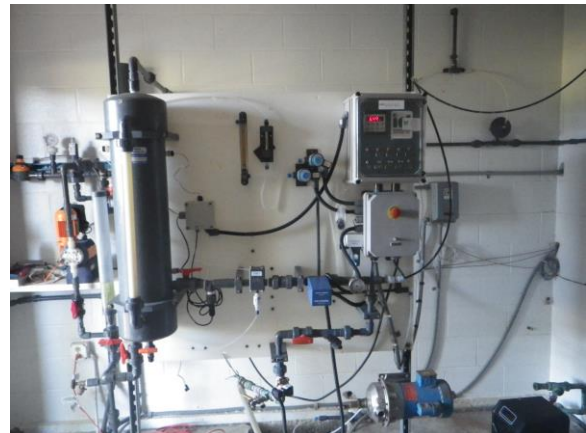
New Dosing Pumps

The entire facility was constructed in 1987 and there have been no major rehabilitations or repairs performed to date. The dosing pumps were rebuilt in 2018. A direct connection to the treatment plant was installed in 2018 for real time monitoring with SCADA, including flow, chemical dosing and alarms.

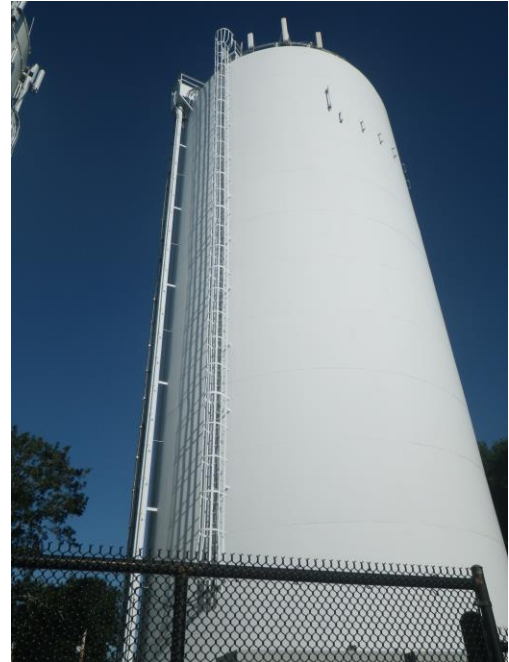
Standpipe #2

Recent Rehabilitation/Repairs: The new standpipe is approximately five years old and is in excellent condition. The tank was recently inspected in June 2013 and no deficiencies were identified

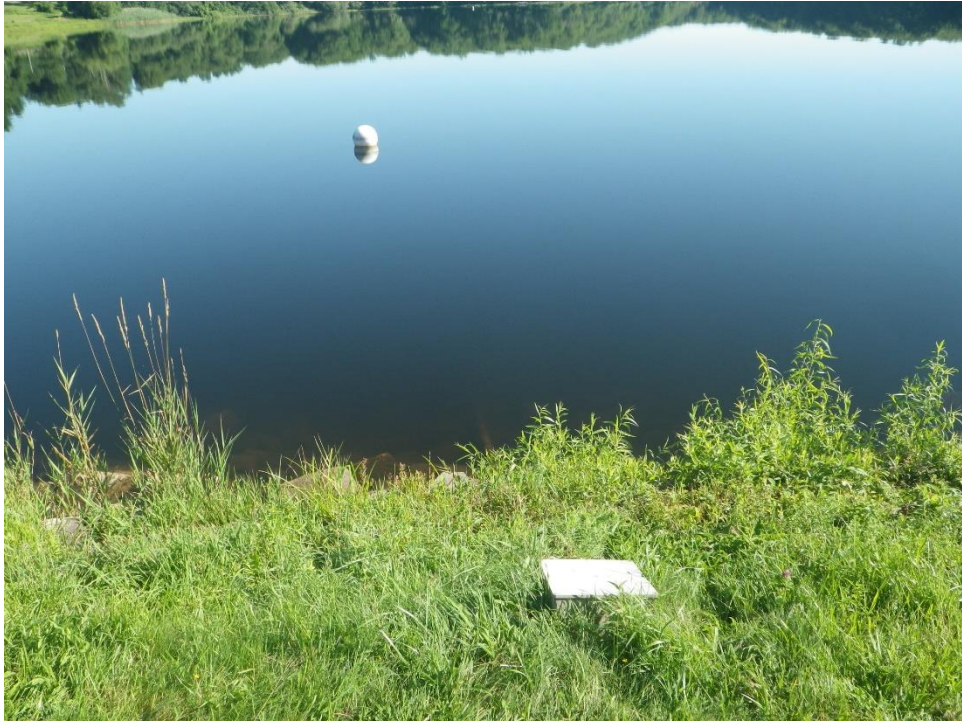
INTAKE AREA

The intake structure for the water supply system consists of a flexible intake pipe connected to a mooring set about 12” below the water surface to obtain the best water quality. The intake connects to a 10” pipe that penetrates the dam and carries the water by gravity to South Pond. The connection between the mooring and the dam penetration is reported to be in fair condition and will require a repair to ensure its long-term integrity.

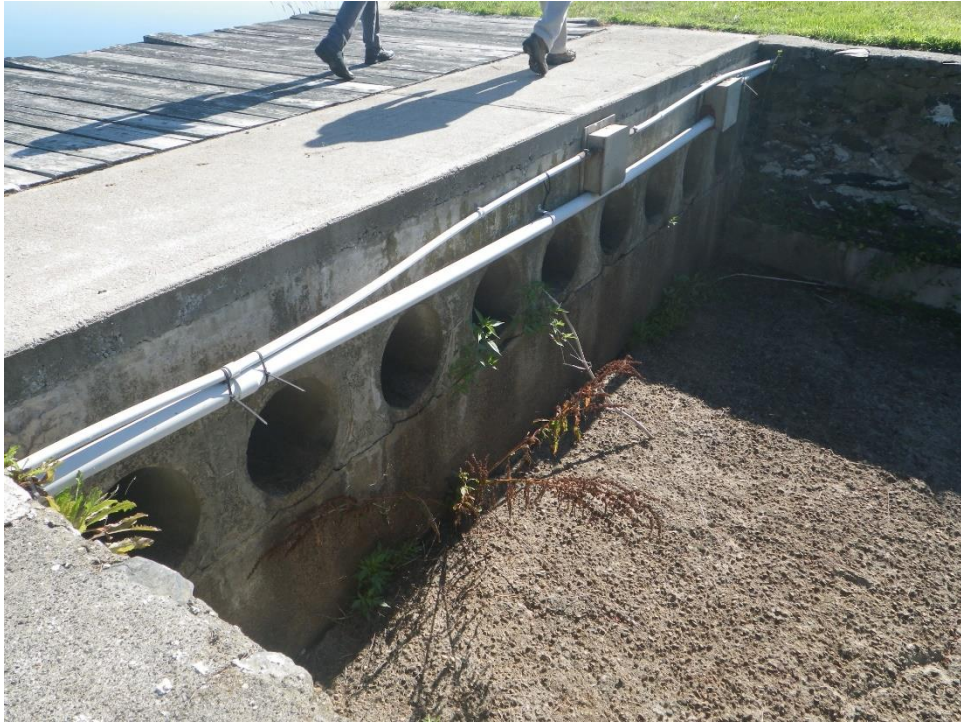
SPILLWAY

<u>Spillway</u> : Fair - Cast in Place Concrete & Field Stone Escarpments	10 years
<u>Dam</u> : Fair, repaired in 1995, toe drain installed in 2010, active seepage remains	10 years
<u>Intake structure and area</u> : Fair, per JWD personnel	5 years
<u>Pond Aeration Building</u> : Good.	10 years
<u>Blower Motor</u> : Very good, recently replaced	10 years

Time Interval/Year	Description	Opinion of Probable Construction Cost
5-year/2019	Flatten dam embankment, extend toe drain, provide upstream slope protection	\$50,000
	Spillway repairs;	\$10,000
	Intake Repairs	\$5,000
	DEM inspection performed March 2019	\$0
5-year/2024	Inspect dam, intake structure and spillway	\$3,500
10-year/2029	Inspect dam, intake structure and spillway	\$3,500
10-year/2029	Replace Pond aeration building and blower motor	\$15,000
15-year/2034	Inspect dam, intake structure and spillway	\$4,000
20-year/2039	Inspect dam, intake structure and spillway	\$4,500

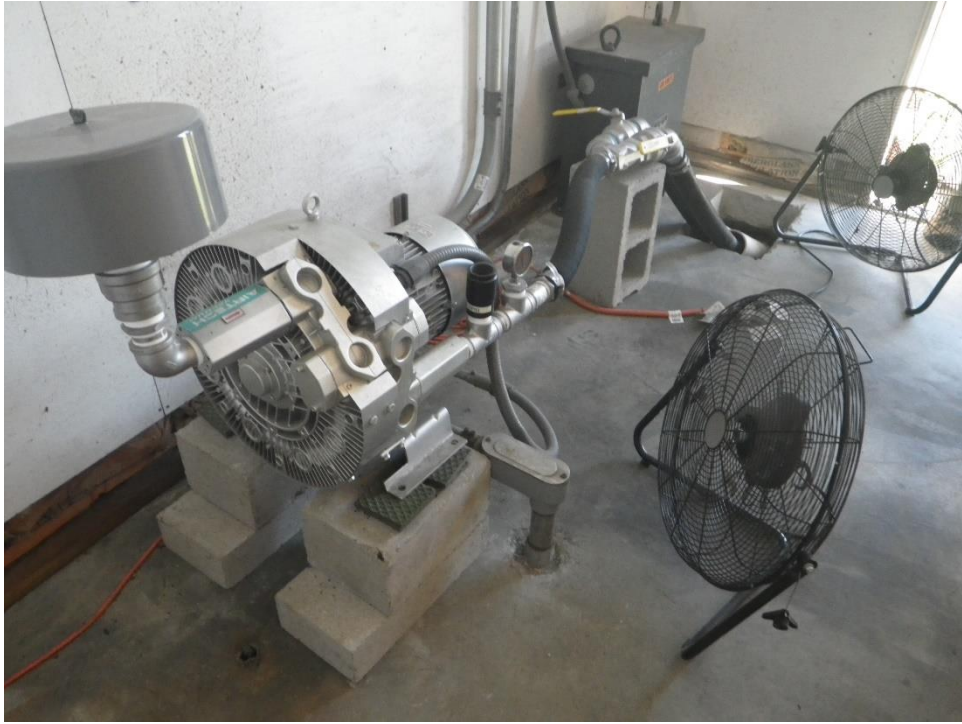
BLOWER MOTOR

A wood-frame building (constructed circa 1995) located west of the dam currently houses a blower motor and associated electrical controls that are part of an aeration system used to improve water quality in the pond. This system was installed circa 2012 which replaced the former compressed air system. Since the motor runs hot, two ventilation fans are used to keep the motor cool. The JWD should monitor this system and consider providing improved ventilation and cooling to preserve the life of the motors.
