PARE PROJECT NO. 17103.00

**CLEAN WATER INFRASTRUCTURE
REPLACEMENT PLAN**

JAMESTOWN WATER DISTRICT

JULY 2019

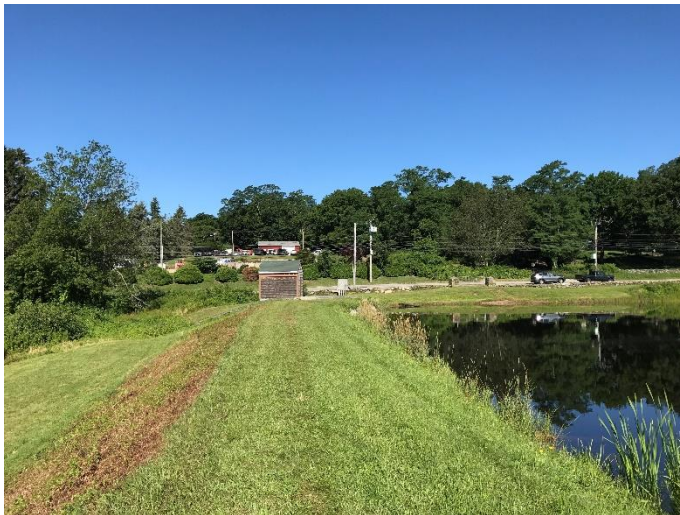
North Pond Dam – Looking West

An approximately 1,000-foot long earthen embankment dam extends across the southern end of the pond.

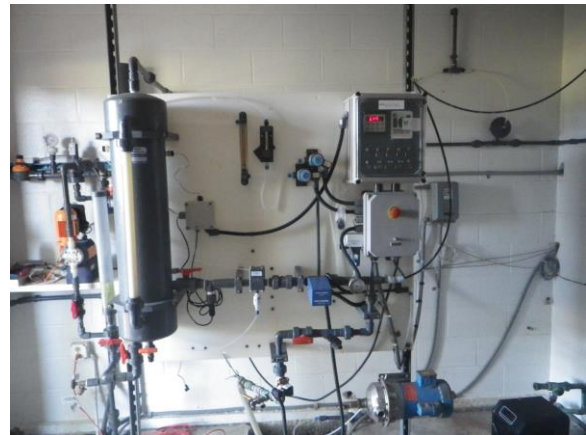
New Dosing Pumps

The entire facility was constructed in 1987 and there have been no major rehabilitations or repairs performed to date. The dosing pumps were rebuilt in 2018. A direct connection to the treatment plant was installed in 2018 for real time monitoring with SCADA, including flow, chemical dosing and alarms.

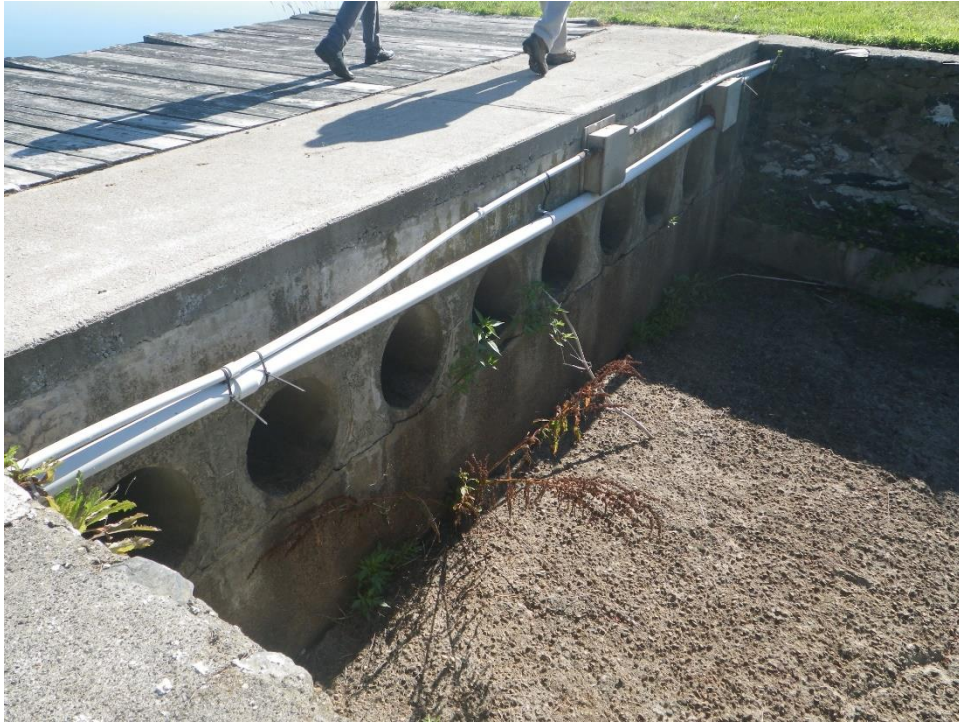
SPILLWAY

<u>Spillway</u> : Fair - Cast in Place Concrete & Field Stone Escarpments	10 years
<u>Dam</u> : Fair, repaired in 1995, toe drain installed in 2010, active seepage remains	10 years
<u>Intake structure and area</u> : Fair, per JWD personnel	5 years
<u>Pond Aeration Building</u> : Good.	10 years
<u>Blower Motor</u> : Very good, recently replaced	10 years

Time Interval/Year	Description	Opinion of Probable Construction Cost
5-year/2019	Flatten dam embankment, extend toe drain, provide upstream slope protection	\$50,000
	Spillway repairs;	\$10,000
	Intake Repairs	\$5,000
	DEM inspection performed March 2019	\$0
5-year/2024	Inspect dam, intake structure and spillway	\$3,500
10-year/2029	Inspect dam, intake structure and spillway	\$3,500
10-year/2029	Replace Pond aeration building and blower motor	\$15,000
15-year/2034	Inspect dam, intake structure and spillway	\$4,000
20-year/2039	Inspect dam, intake structure and spillway	\$4,500

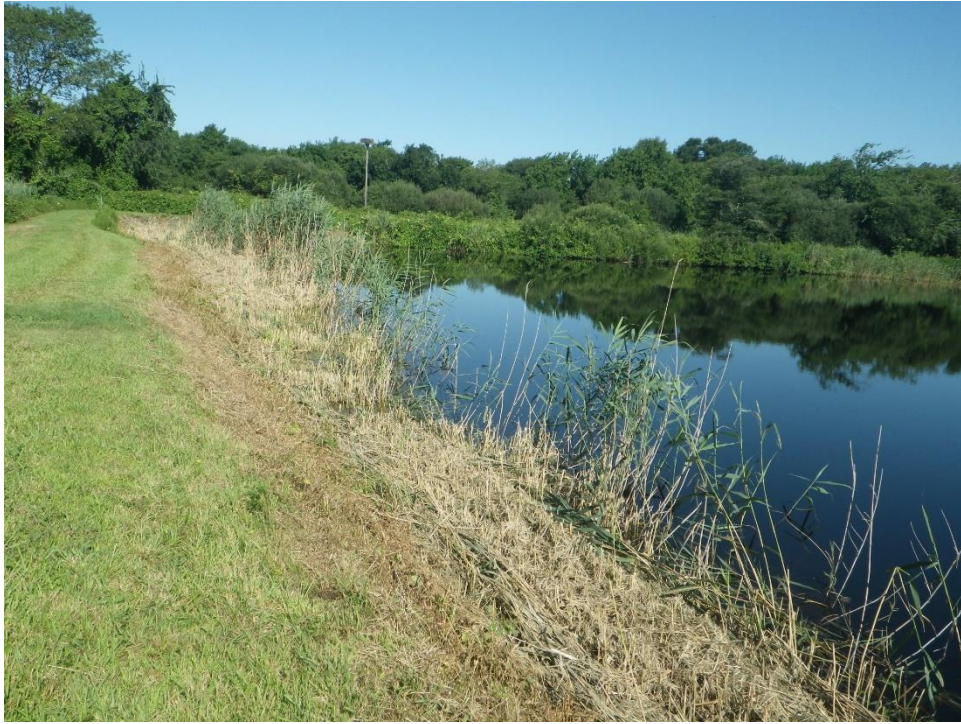
SOUTHEAST CORNER OF DAM – LOOKING WEST

Visual inspections performed by Pare as recently as 2013 identified concerns with the dam at South Pond that require remediation. Specifically, the dike was found to be deteriorated with low areas, breaches, root penetration and other deficiencies. It

In 2018, Pare prepared design documents for the completion of a rehabilitation program at the dam and dike at South Pond to address the issues raised in previous visual inspections including the deteriorated condition of the dike, seepage, inadequate spillway discharge capacity, and lack of upstream slope protection. The designs consists of the following components:
