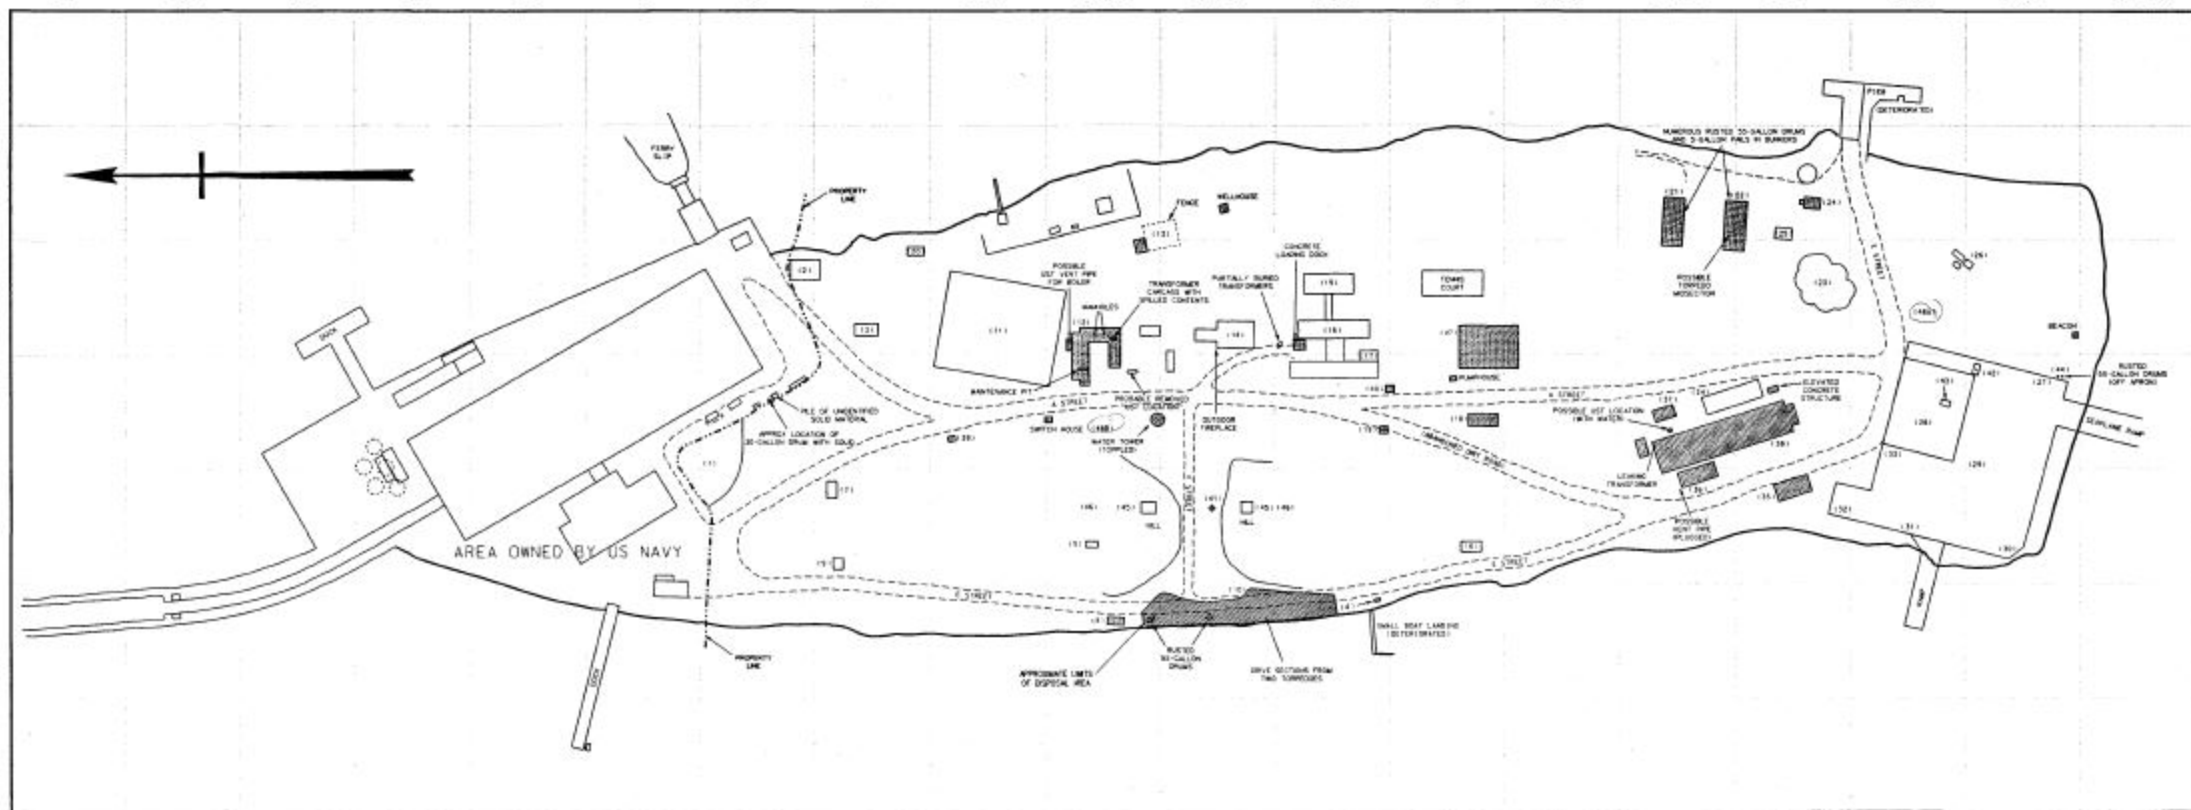
NED SITE NUMBER	NED SITE NAME
1	COAL STORAGE
2	MARINE BARRACKS (FOUNDATION REMAINING)
3	FORMER CARPENTERS SHOP
4	PUMP HOUSE
5	FORMER UNKNOWN BUILDING #2
6	UNKNOWN BUILDING #3
7	FORMER UNKNOWN BUILDING #4 (FOOTINGS REMAINING)
8	INCINERATOR
9	MAGAZINE (IGNITOR STORAGE)
10	DISPOSAL AREA #14
11	FORMER GUNSET HUTS/MAINTENANCE SHOPS
12	MAINTENANCE SHOP/GARAGE/FIRE STATION
13	ELECTRIC SUBSTATION TRANSFORMER PEN
14	FORMER MARINE BARRACKS (CONCRETE LOADING DOCK REMAINING)
15	FORMER RECREATION BUILDING
16	FORMER BARRACKS
17	FORMER TRANSFORMER VAULT
18	WATER TREATMENT PLANT
19	TORCH POT STORAGE
20	FORMER CABLE TERMINAL BUILDING
21	BUNKER #11
22	BUNKER #12
23	COAL STORAGE
24	CABLE TERMINAL BUILDING
25	UNDERGROUND STORAGE TANKS
26	GAS PUMP HOUSE/GAS TANKS (REMOVED)
27	TWO GAS PITS
28	FORMER ORDNANCE TEST FACILITY, HANGER
29	FORMER UNKNOWN BUILDING #1 (HANGAR 5496-61)
30	FORMER PYROTECHNIC STORAGE
31	GAS PIT
32	FORMER DRUM STORAGE AREA

33	FORMER PAINT AND OIL STORAGE
34	THEATER/RESEARCH BUILDING (FOUNDATION REMAINING, CONCRETE PLATFORM)
35	BOILER HOUSE

POTENTIAL CONTAMINATION CONCERNS
OPEN PILE, UNLINED LEACHING
POTENTIAL UST/AST
POTENTIAL UST/AST, OTHER DEBRIS
SALT WATER, SEWAGE, PCB
DEBRIS, DARKENED OR STAINED AREAS EVIDENT ON PHOTOS
DEBRIS, DARKENED OR STAINED AREAS EVIDENT ON PHOTOS
POSSIBLE SMALL BUNKER USED FOR STORAGE, GAS TANKS (NO EVIDENCE FOUND IN FIELD)
WASTE
IGNITOR WASTE
WASTE DUMP
CHEMICAL WASTE OR DEBRIS FROM MAINTENANCE OPERATIONS
MATERIALS OR DEBRIS WASTE, FLOOR DRAINS, UST REMOVED BY THE NAVY, TRANSFORMER
POTENTIAL UST/AST, TRANSFORMERS
POTENTIAL UST/AST (NO EVIDENCE FOUND IN FIELD)
POTENTIAL UST/AST (NO EVIDENCE FOUND IN FIELD)
POTENTIAL UST/AST (NO EVIDENCE FOUND IN FIELD)
TRANSFORMER CHEMICAL LEAKS (NO EVIDENCE FOUND IN FIELD)
TREATMENT CHEMICALS
FUEL TORCHES
POTENTIAL UST/AST (NO EVIDENCE FOUND IN FIELD)
FORMER PISTOL RANGE, WARHEAD STORAGE, POSSIBLE DRUMS
WARHEAD STORAGE
OPEN PILE, UNLINED LEACHING
POTENTIAL UST/AST
POSSIBLE UST EVIDENT IN AERIAL PHOTO

TWO USTs REMOVED BY THE NAVY, AREA EXCAVATION AND FILLING
GAS STORAGE, SPILLAGE, RUNOFF, UNLINED AREA (NO EVIDENCE FOUND IN FIELD)
POSSIBLE ORDNANCE TESTING, FLOOR DRAINS
POSSIBLE ORDNANCE TESTING, FLOOR DRAINS
GAS STORAGE (NO EVIDENCE FOUND IN FIELD)
GAS STORAGE, SPILLAGE, RUNOFF, UNLINED AREA (NO EVIDENCE FOUND IN FIELD)
55 GALLON DRUMS EVIDENT ON PHOTOS (NO EVIDENCE FOUND IN FIELD)
DRUMS AND CANS PRESENT, POSSIBLE LEAKAGE (NO EVIDENCE FOUND IN FIELD)
FORMER RESEARCH BUILDING
POTENTIAL UST

NED SITE NUMBER	NED SITE NAME
36	DEGAUSSING BUILDING
37	MISCELLANEOUS STORAGE
38	STORAGE
39	WELLHOUSE #81
40	WELLHOUSE #78
41	AA GUNS ELECTRICAL SUPPLY (UTILITY POLE REMAINING)
42	5,000 GAL TANK (AVGAS)
43	FORMER PAINT SHED
44	EMPTY DRUMS
45	FORMER FIRE APPARATUS HOUSES (TWO)
46	FORMER GUN EMPLACEMENTS
47	UNDERGROUND WATER TANK
48A	BACKGROUND SAMPLE #1 LOCATION
48B	BACKGROUND SAMPLE #2 LOCATION

POTENTIAL CONTAMINATION CONCERNS
POTENTIAL UST, ELECTRICAL EQUIPMENT
UNKNOWN STORAGE CONTENTS
FORMER 1919 WARHEAD STORAGE, TRANSFORMER
TRANSFORMER
TRANSFORMER
TRANSFORMER (POLE MOUNTED - NO EVIDENCE OF TRANSFORMER FOUND IN FIELD)
FUEL SPILLAGE, UST (NO EVIDENCE FOUND IN FIELD)
SOLVENT SPILLAGE
DRUMS PRESENT, POSSIBLE LEAKAGE
POTENTIAL UNDERGROUND ORDNANCE BUNKERS

AREAS OF POTENTIAL UNDERGROUND STORAGE TANK(S) OR DISPOSAL AS INTERPRETED FROM GEOPHYSICAL SURVEY
	BUILDING/STRUCTURE STILL IN EXISTENCE
